Manhole Inspection Summary

Manhole # S39YY_019MH

Insp Date: **12/14/06 10:06 AM**

Location Address: **3200 AVON AVE**

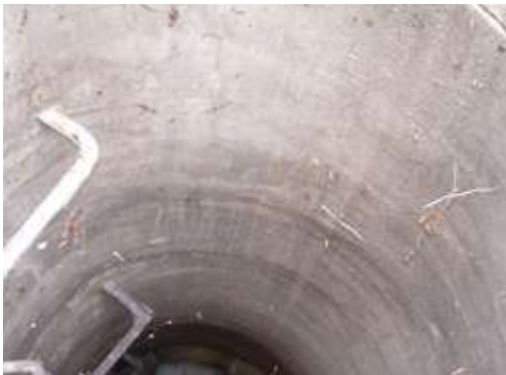
Defect

Infiltration: ☐ None ☒ **Joint** ☐ Cracks ☐ Mortar ☐ Roots ☒ **Wall**

Infiltration: ☐ None ☐ Joint ☐ Cracks ☐ Mortar ☐ Roots ☒ **Wall**

Adjustment and Barrel infiltration.

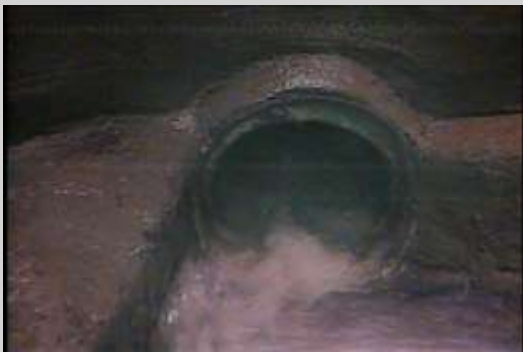
15 in. Circular Gravity Sewer Pipe Out @ 12 O'Clock

Invert Depth: **10.60** (ft.) Flow Characteristics: **Turbulent**

Infiltration: **None** Pipe Seal Cond: **Sound**

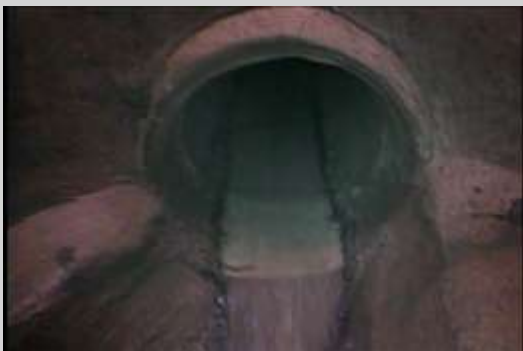
15 in. Circular Gravity Sewer Pipe In @ 3 O'Clock

Invert Depth: **9.80** (ft.) Flow Characteristics: **Fast**

Infiltration: **None** Pipe Seal Cond: **Sound**

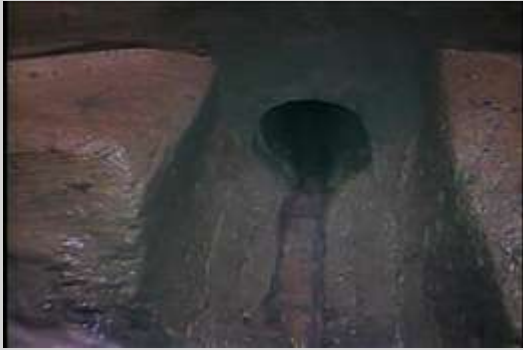
Pipe In @ 6 O'Clock

Invert Depth: **10.05** (ft.) Flow Characteristics: **Slow**

Infiltration: **None** Pipe Seal Cond: **Sound**

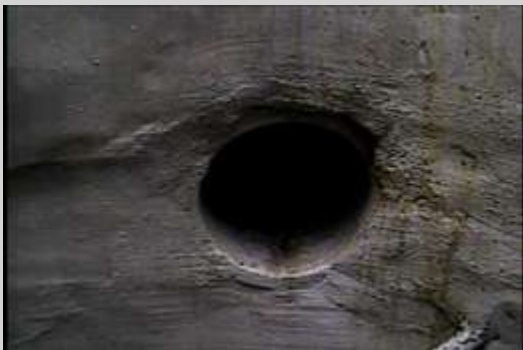
Pipe In @ 7 O'Clock

Invert Depth: **3.15** (ft.) Flow Characteristics: **None**

Infiltration: **None** Pipe Seal Cond: **Sound**
